## 小峰城の石垣

⑥ 清水門石垣の復元  
― 災害復旧で分かったこと ―

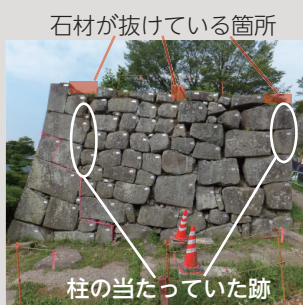
▲修復前の清水門西側の石垣

今回は、清水門石垣の修復において検討した、石垣を元に戻す工夫の一例を紹介します。石垣の一番上の段は、部分的に石材が抜けており、凹凸が見られます。当初は、元々は石材があったと想定し、石材を追加して、まっすぐにそろえる計画でした。

しかし、石垣表面の観察により、石材が抜けている部分の下の石垣表面に、柱が当たっていた跡が確認できました。

門跡の石垣には、柱の当たる部分がくぼむ加工などが施されています。そうした痕跡を損なわずに後世に伝えるため、復元を行いました。

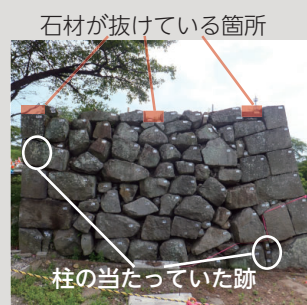
▲修復前の清水門東側の石垣
