## 小峰城の石垣

### ① 災害復旧で分かったこと ① 石垣の構造

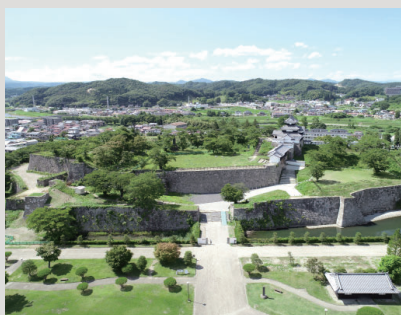
▲石垣の復旧が完了した小峰城

市民の皆さんをはじめ、多くの方々から、復旧に向けた温かいご支援・ご協力をいただき、この春に、東日本大震災で崩落した小峰城の石垣復旧を完了することができました。
